Church of St Mary the Virgin, Belchamp Walter
Treatment report for the paintings by G. W. Brownlow on the
Altar and Pulpit

Report no.: BEL/03
Date: July 2011
Author: Sally Woodcock
130 Coleridge Road
Cambridge
CB1 3PR
Tel. 01223 562244
Photographs: Sally Woodcock, 2009

Ref: BEL/03

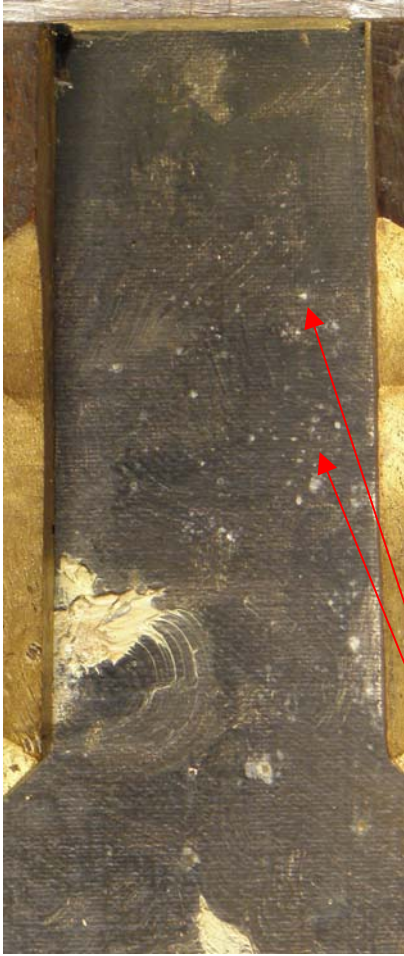
Plate 4. Detail of white spots on the painting of *The Sacrifice of Isaac*

Examination of the wooden supports showed no further deterioration due to woodworm infestation, indicating that the insects are no longer likely to be active. Loose dust and debris was removed from the front of the paintings and the surrounding woodwork with a soft brush and vacuum cleaner. Surface cleaning was carried out with a solution of ammonia diluted in deionised water and applied with cotton swabs. Accretions which were not removed through surface cleaning were carefully removed with the aid of a scalpel. The surface of both paintings had a slight hazy coating and the appearance improved significantly when the paint surface was saturated. It seems probable that furniture polish with a wax content has been used on the surrounding wooden elements has also been applied to the surface of the two main paintings at some time in their history. It was decided to apply a light coat of MS2A varnish (conservation grade synthetic resin) to saturate the paint layers and protect them against future build up of dirt and possible bird excrement. Small areas of loss and abrasion were retouched using artists' quality watercolours.

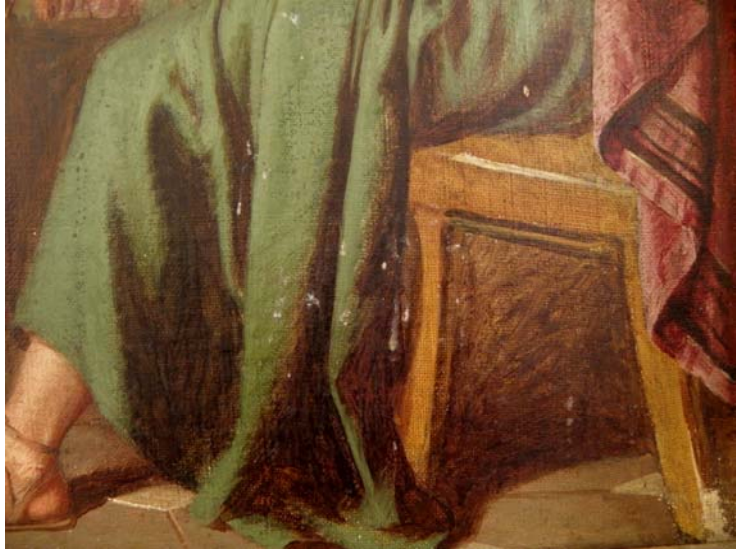
Plate 3. Detail of white accretions on the painting of *The Last Supper*

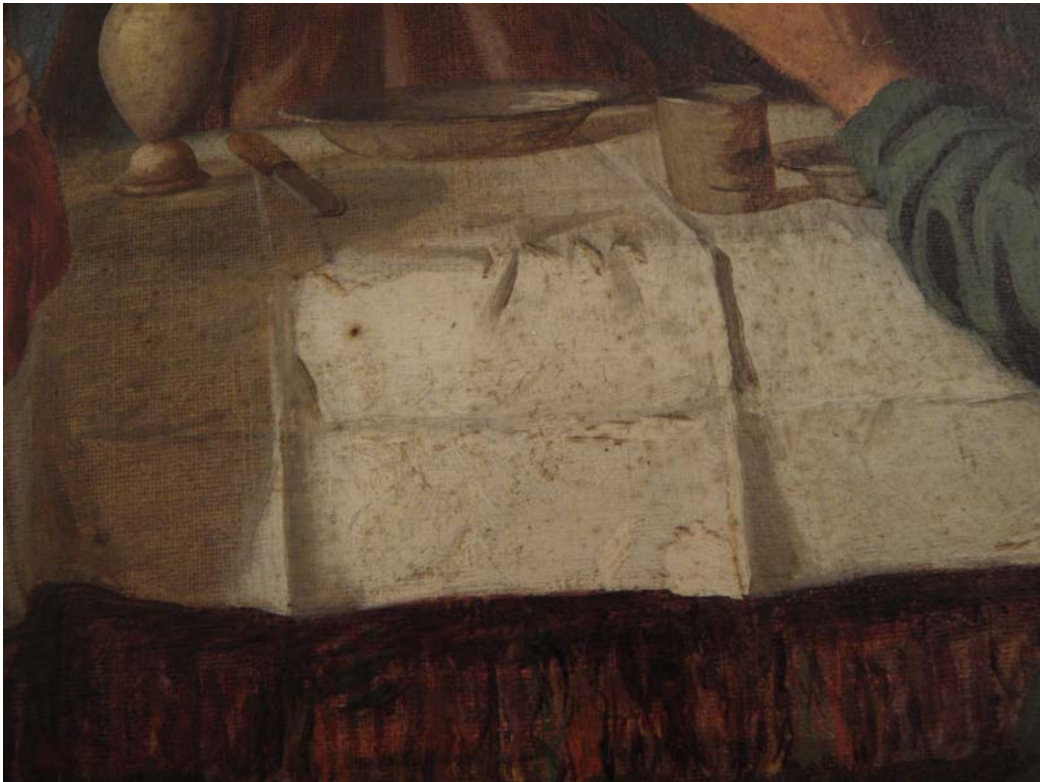
Plate 5. Detail of surface dirt on the painting of *The Last Supper*

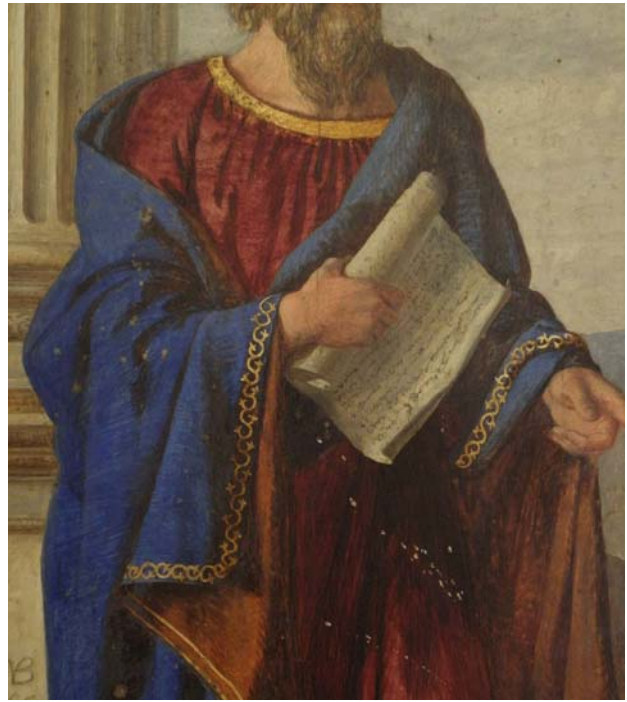
Plate 13. Detail of *St Matthew*, showing loss and discoloured areas

As with the paintings on the altar, all four large paintings on the pulpit had a hazy surface coating that is particularly disturbing and opaque on the figures of St John and St Luke. It seems likely to be caused by an application of a wax containing polish used on the wooden elements of the pulpit. Attempts were made to remove this layer with different solvent mixtures. A 1:3 mixture of industrial methylated spirits and white spirit was found to be effective at thinning this layer. The waxy layer had also imbibed a considerable amount of dirt. Although the solvents thinned the layers it was not possible to completely remove the coating without affecting the paint layers below. A thin layer of MS2A was applied to the surface of the four large paintings, to saturate the paint surface and minimise the hazy appearance of the wax coating. Losses in the paint layers and areas of discolouration were retouched using artist quality watercolour.

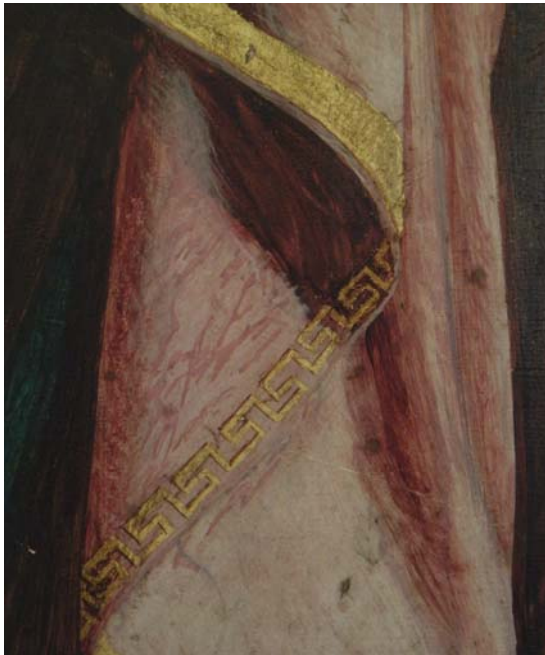
Plate 14. Detail of discoloured retouching on *St Mark*

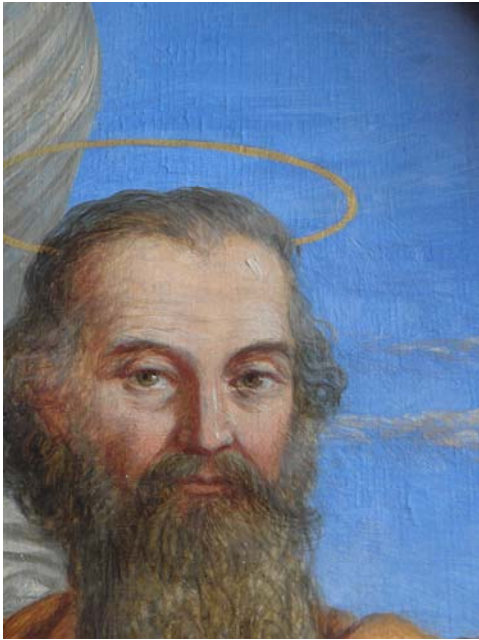
Plate 16. Detail showing areas of raised paint around the head of St Luke

Loose dust and debris was removed from the surface of the paintings and the surrounding wooden elements with a soft brush and vacuum cleaner. Areas of raised paint on the panel of St Luke were consolidated and laid flat using Lascaux 4176 adhesive. The adhesive was brushed onto the fine cracks in the paint surface and excess was cleared with deionised water. The raised areas of paint were then massaged back into plane using a heat-controlled spatula. Surface cleaning was carried out using a solution of ammonia diluted in deionised water. What was believed to be areas of mould growth in the preliminary report, on the blue paint of St Matthew, was not readily removed following cleaning. These circular areas of discolouration may be connected with pigment deterioration within the paint.

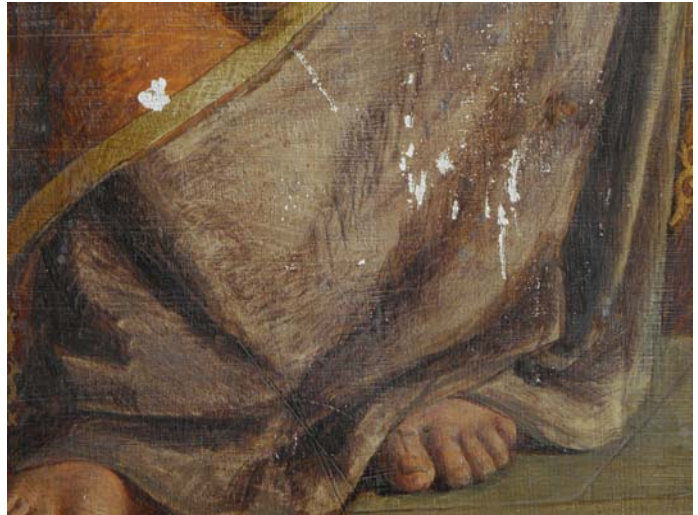
Plate 17. Detail of loss and abrasion on the panel of *St Luke*

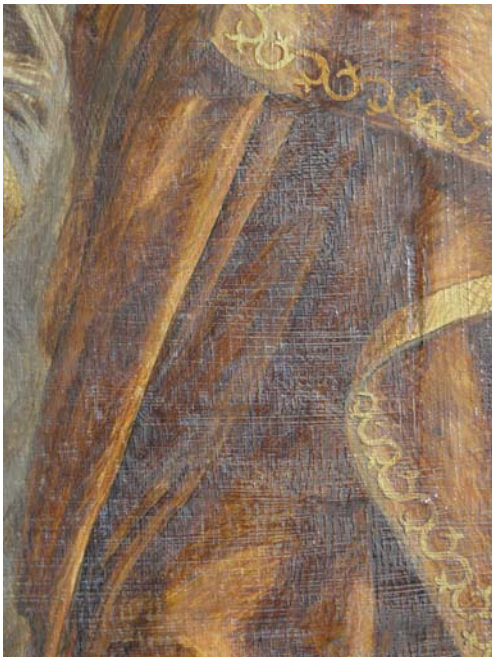
Plate 18. Detail of hazing, *St Luke*

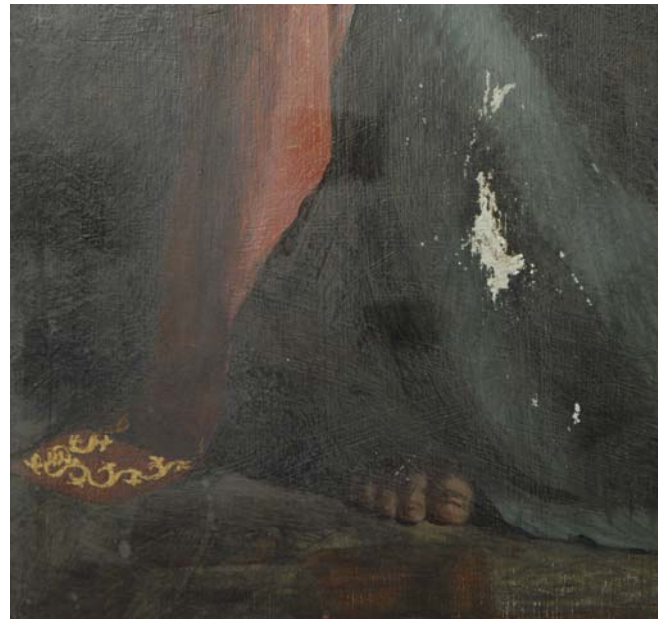
Plate 19. Detail of hazing and cleaning tests, *St John*
